NL INDUSTRIES/TARACORP SUPERFUND SITE GROUP
Leed Environmental, Inc.
Van Reed Office Plaza
2209 Quarry Drive, Suite C-35
Reading, PA 19609
Telephone: (610) 670-7310
Facsimile: (610) 670-7311

Re: NL Industries/Taracorp Superfund Site; Granite City, Illinois
First 2019 Semi-Annual Operation and Maintenance Inspection (May 2019)

Inspection Date: 5/20/2019

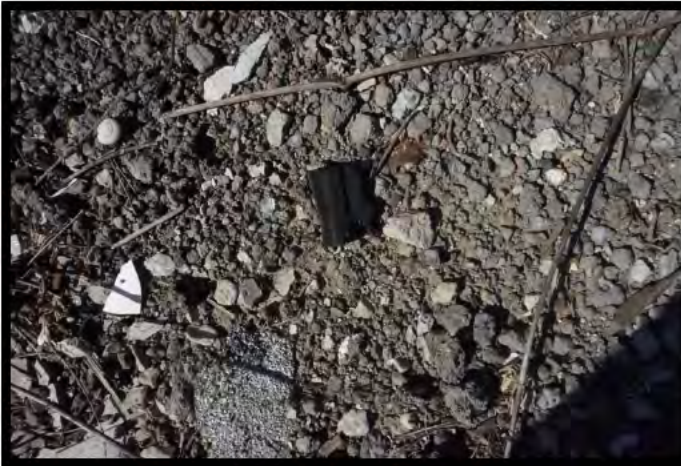
Photograph 9: Slough Road, scattered battery case chips on concrete surface of former Robin's Nest Lounge.

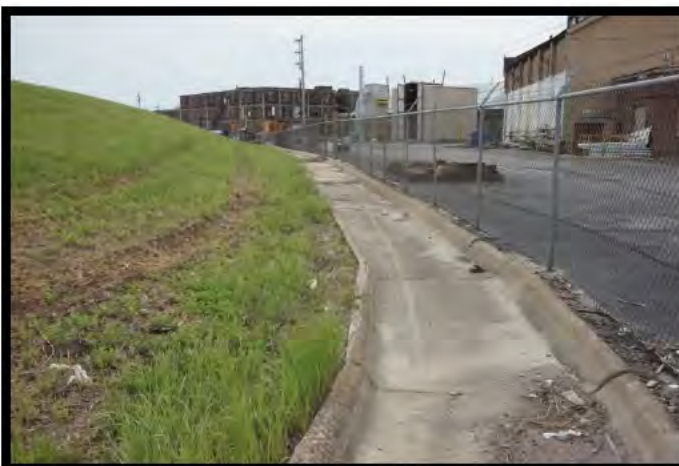
Photograph 16: Concrete drainage swale, crack in concrete along northwestern side of Taracorp pile.

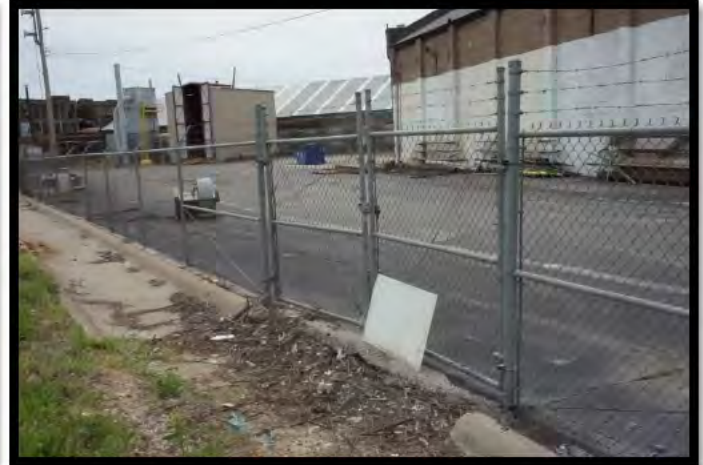
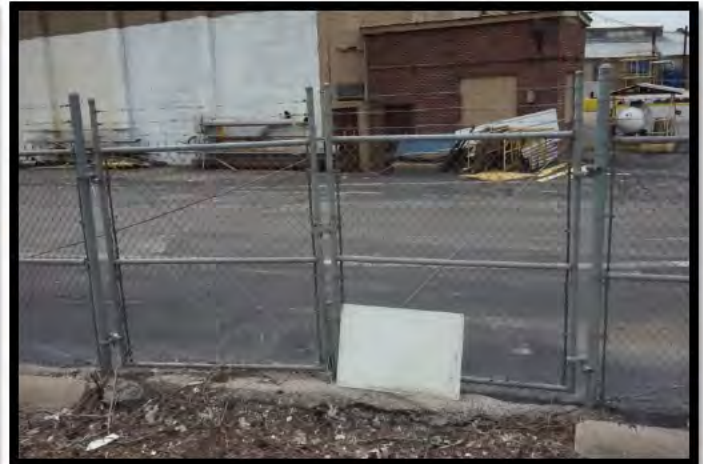
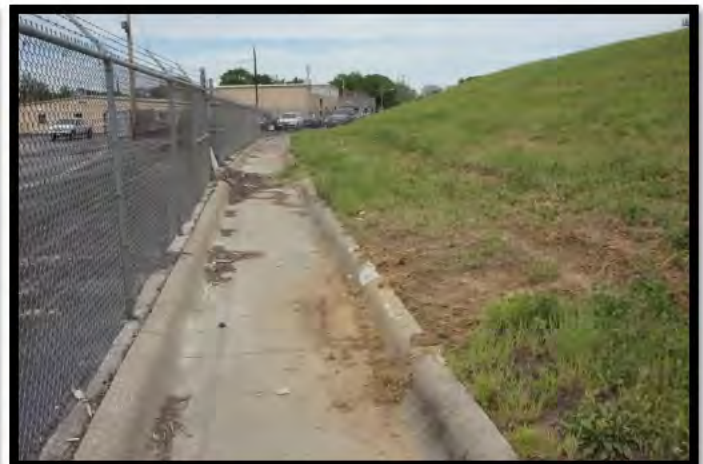
Evidence of rust, cuts, deterioration, or other damage	Yes	No		
Evidence of tampering	Yes	No		
Securely affixed to fence	Yes	Yes	Warning sign on northwestern side of Taracorp pile was not attached to the fence.	The Group requested a proposal from TNT Fence Company to reaffix the sign and to check wire ties for other warning signs.
Signs legible	Yes	No		
Comments				
Access Road				
Evidence of settlement or deterioration	Yes	No		
Comments			No access road problems.	
Taracorp Pile - Vegetation				
Adequate growth of vegetation	Yes	No		
Adequate diversity of vegetation	Yes	No		
Evidence of stress	Yes	No	No stress; thick vegetation.	
Presence of trees, shrubs, woody bushes	Yes	No	No trees, shrubs, etc. observed.	
Need for mowing/maintenance	Yes	No		
Comments			The Group's contractor, Munie Greencare Professionals (Munie), cut the vegetation on the flat parts of 1555 State Street property and the Taracorp pile cap on May 17, 2019.	Following the inspection, the Group requested that Munie cut the vegetation along the State Street sidewalk.

Photograph 20: Fence, warning sign (fallen from fence), western side of Taracorp pile.

Photograph 21: Fence, warning sign (fallen from fence), western side of Taracorp pile.

Photograph 22: Fence, warning sign (fallen from fence), western side of Taracorp pile.

Photograph 23: Fence, warning sign (fallen from fence), western side of Taracorp pile.

- The Group has requested a proposal from its fence contractor, TNT Fence Company, to repair a short section of damaged fence along the railroad tracks (Attachment 5, photographs 94-95), to reaffix a warning sign to the security fence along the northwestern side of the Taracorp pile (Attachment 5, photographs 20-23), and to check the security of wire ties used to affix other warning signs onto the fence.

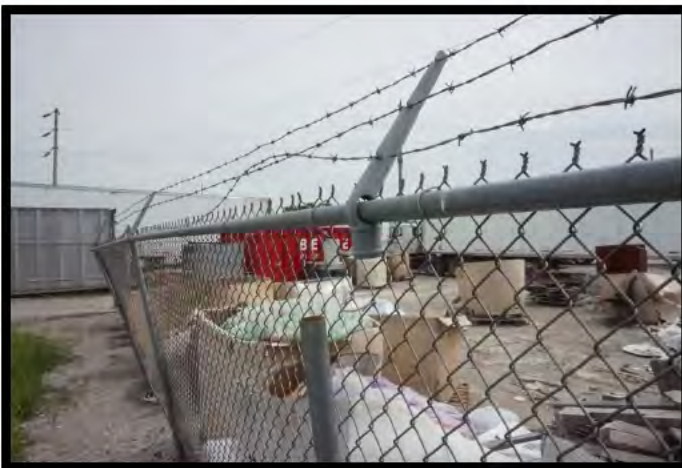
Photograph 40: Broken fence pole (material staging on State Street Warehouse property).

- The Group has notified the owner/operator of All Pallet Services, one of the companies that operates on the neighboring property, and has requested that All Pallet Services address several fence issues attributable to its operations. Those issues include repairing a bent section of fence, repairing barbed wire and a separated fence post, and addressing litter (Attachment 5, photographs 38-44).

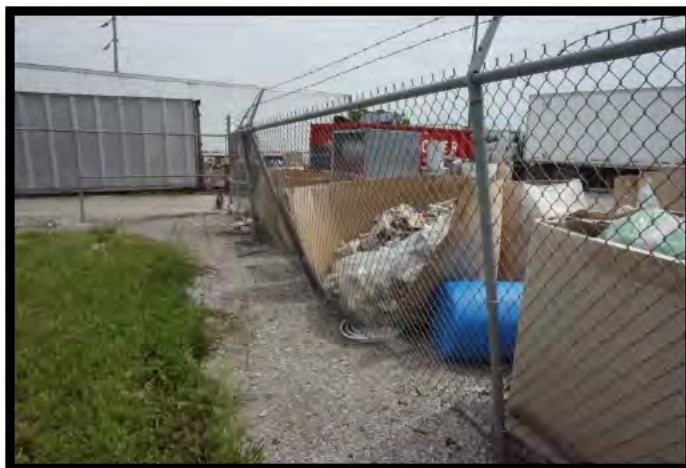
Photograph 41: Bent fence (material staging on State Street Warehouse property).

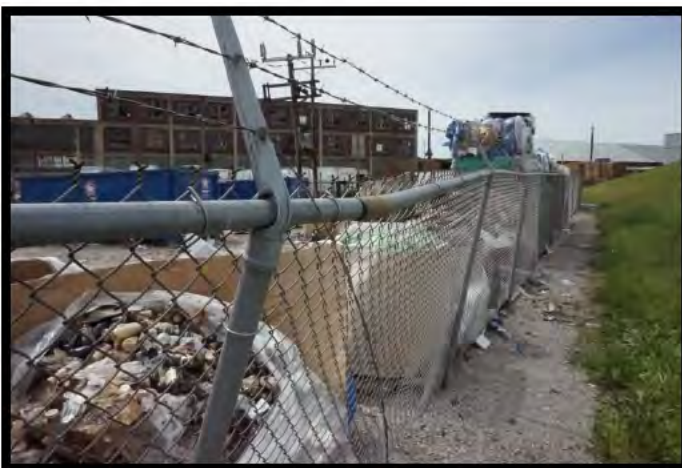
Photograph 42: Bent fence and broken barbed wire (material staging on State Street Warehouse property).

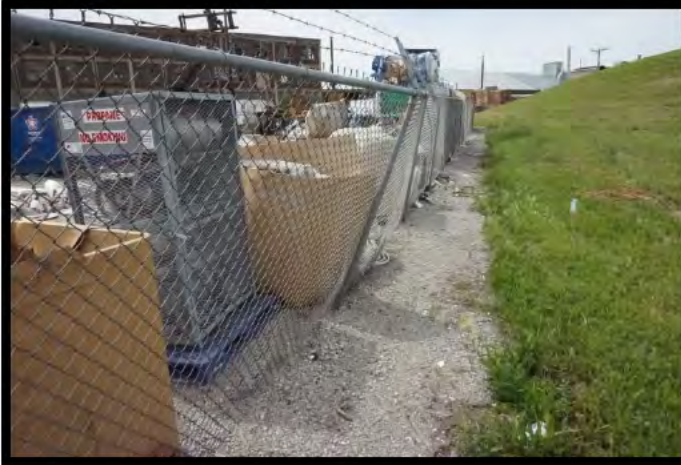
Photograph 43: Bent fence and broken barbed wire (material staging on State Street Warehouse property).

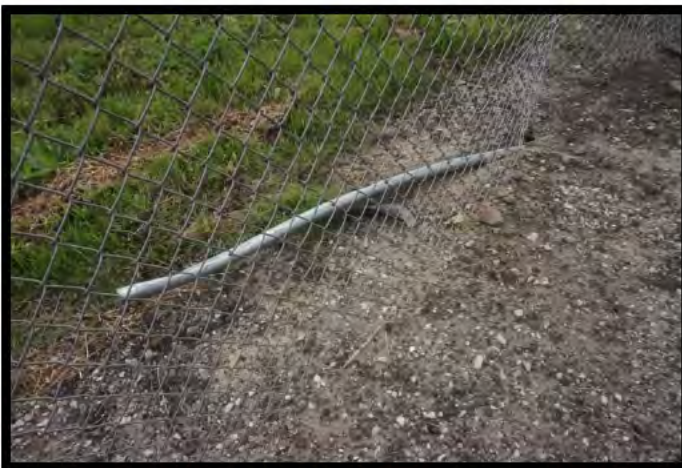
Photograph 94: Broken fence post along railroad tracks.

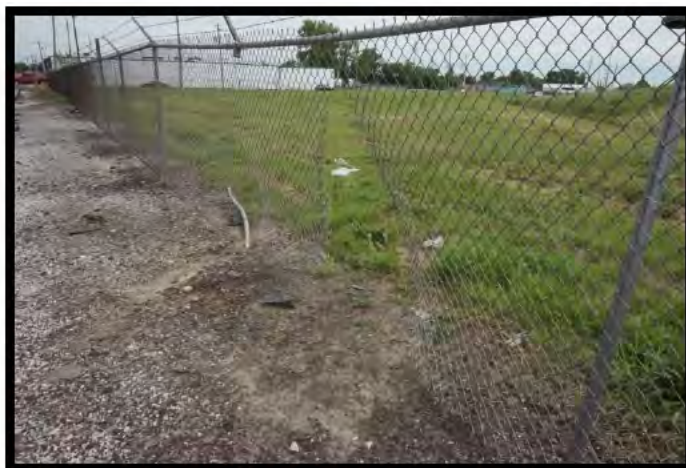
Photograph 95: Torn fence fabric along railroad tracks.

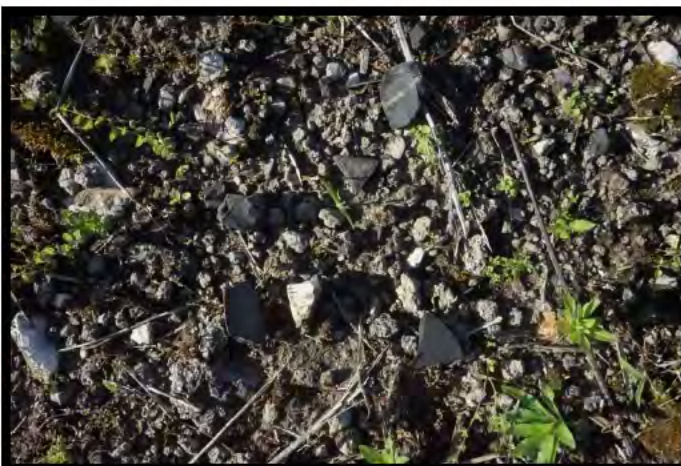
- At Sand Road (also a remote fill property remediated by EPA), some scattered battery case chips are visible on the ground surface within the foundation area of a former building on the property (Attachment 7, photograph 9). No evidence of disturbance of the soil cover was observed.

Photograph 11: Sand Road property, battery case chips on ground surface inside concrete foundation.
